Inspected By: Eric Cree, OH License # OHI.2021003744 EXP. 6/9/2024

Home Inspection Report

**1234 Bright Street
Sylvania, OH 43560**

Inspected on Sat, Feb 20 2021 at 9:00 AM

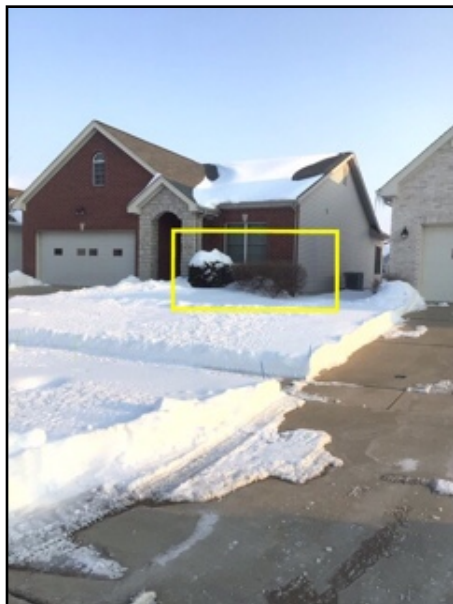
Figure 4-1

Recommend maintaining the two bushes in the front of the house to allow for enough air flow and sunlight to properly dry the exterior of the house.

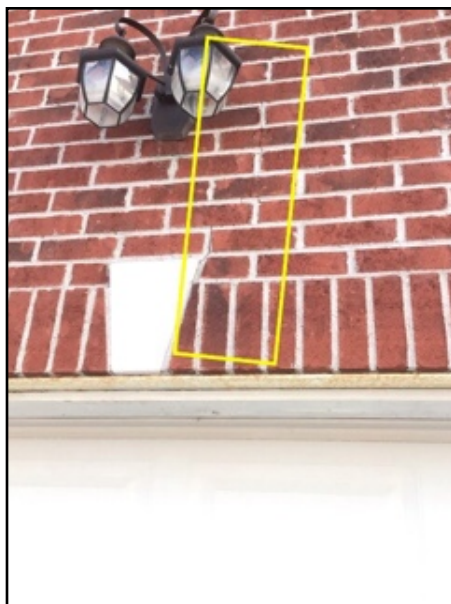
Figure 7-1

The brick veneer was, for the most part, unremarkable with the exception of one vertical crack above the middle of the garage. This is most likely a settlement crack.

Recommend that the very minor crack above the garage door be sealed with mortar caulk as a guard against further deterioration.

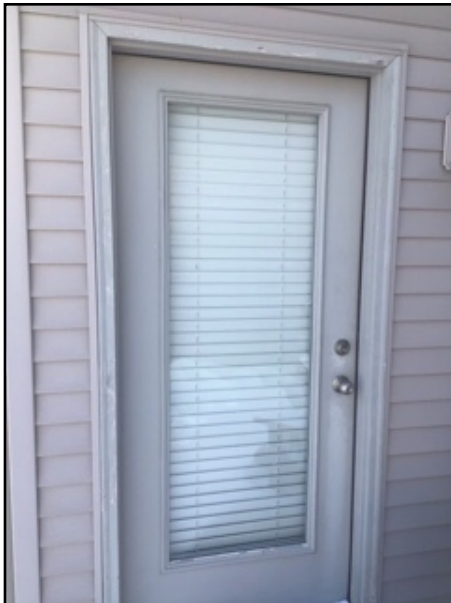
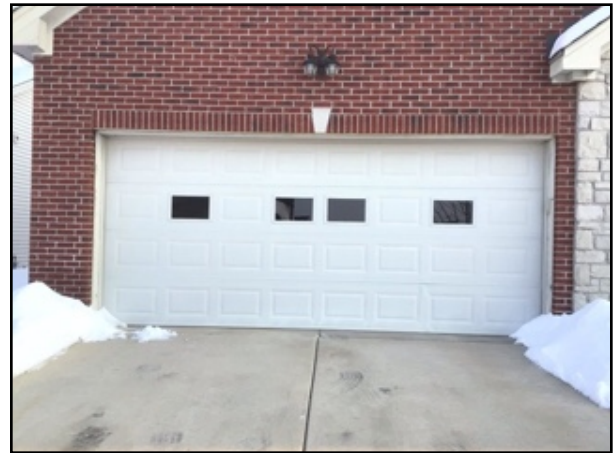
Scrape and paint areas of wood trim around exterior back door and garage trim to prevent wood rot. This should be regular maintenance every couple years.

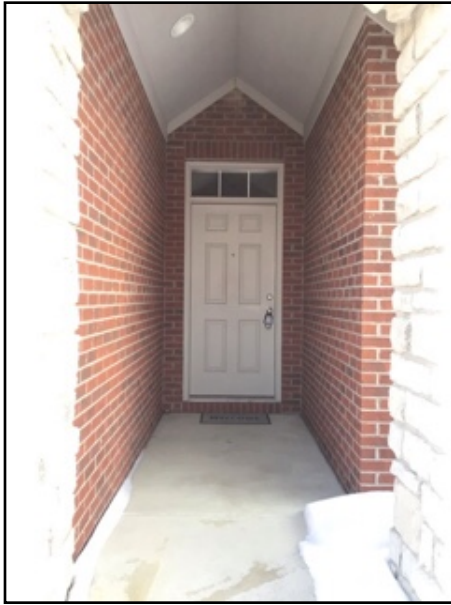
Figure 10-1

Exterior front door was metal with transom window. It was hung straight and plum and articulated properly with its latches.

The steel lintel above the door displayed proper flashing.

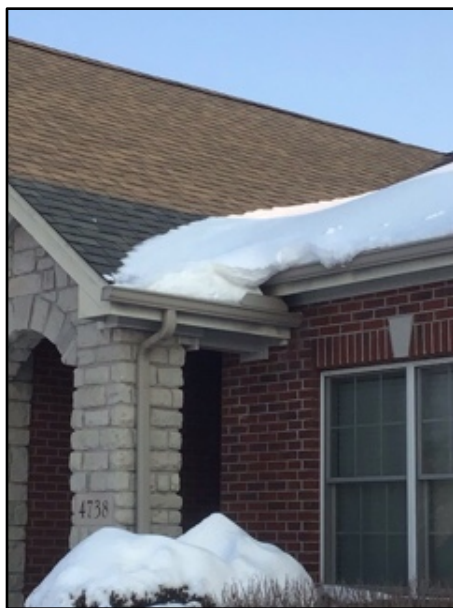
Figure 14-1

The roof is covered with asphalt fiberglass shingles in architectural style. The roof displayed no signs of missing shingles, cupping, fishmouth or displacement.

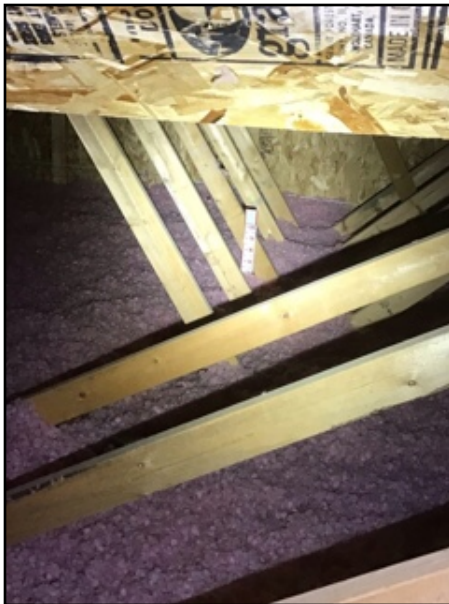
Figure 19-1

The attic was insulated with approximately 12" of blown-in fiberglass insulation.

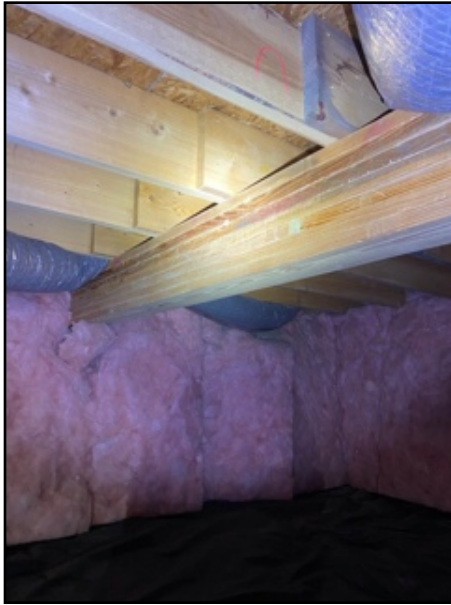
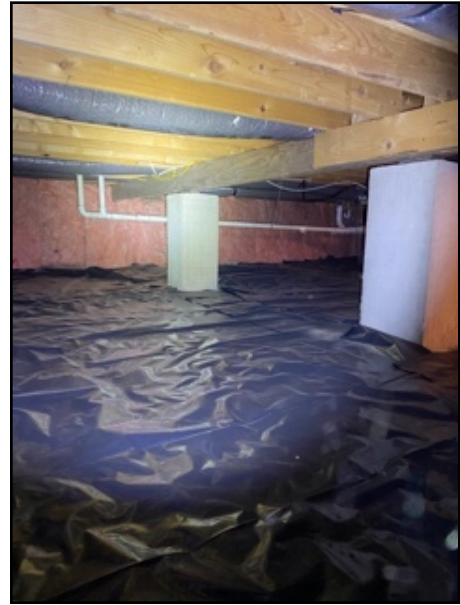
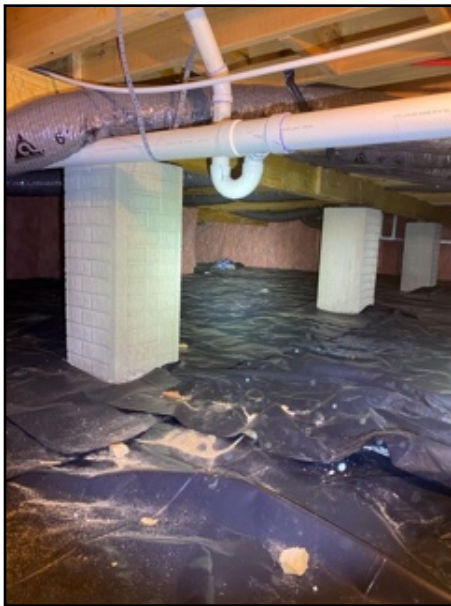
Structure was supported by wood beams and supported by poured concrete columns. The wood beams displayed no signs of rot, staining or physical damage. The poured concrete columns displayed no signs of cracking and are not displaced.

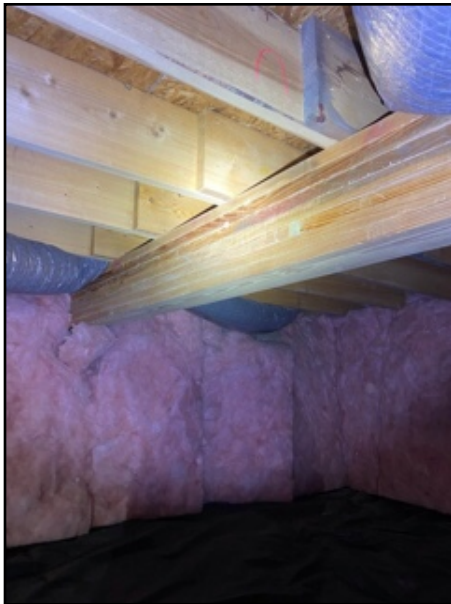
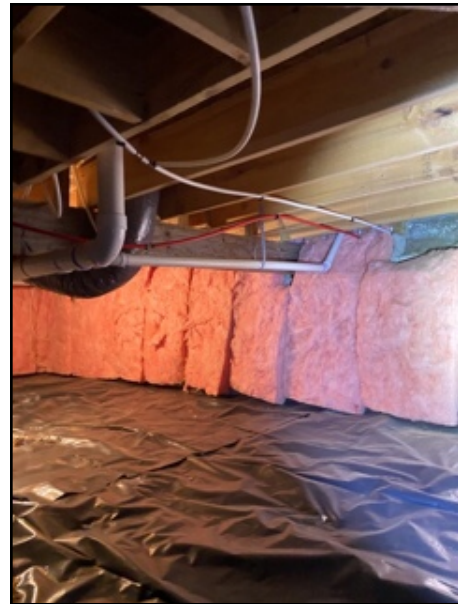
Floor structure was 2 x 10 wooden joists that supported plywood sub-flooring. These joists were without signs of water staining, rot or twist and were securely mounted on the foundation and the wood beam. Where they rest on the foundation wall, they displayed no signs of water staining and exhibited no signs of softness at their ends. The sub-flooring displayed no signs of water staining.

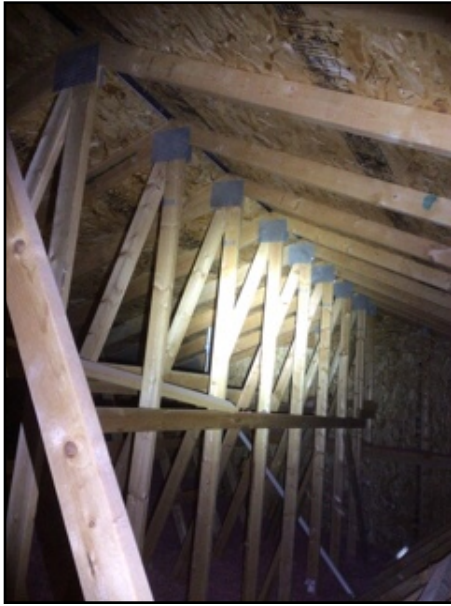
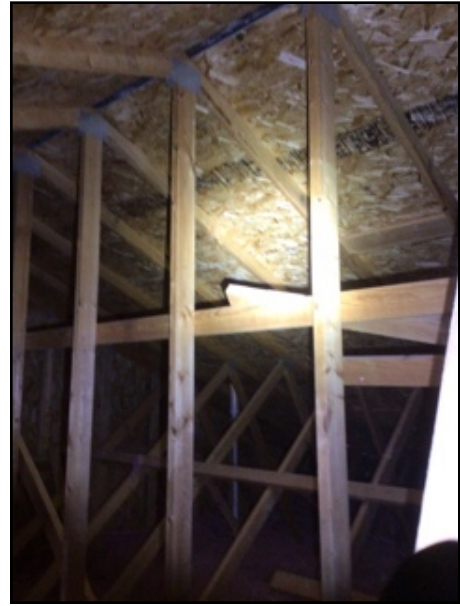
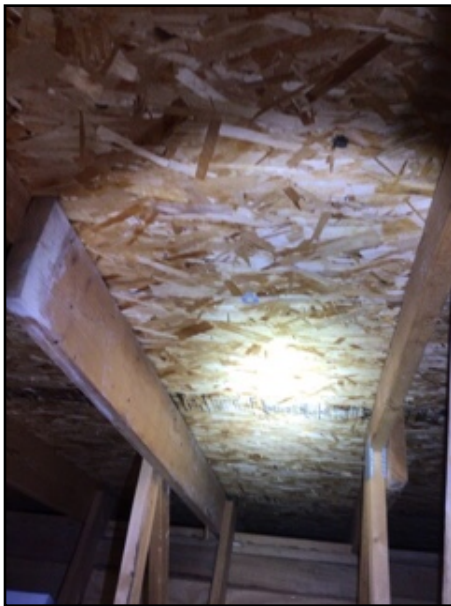
Attic structure was 2 x 4 wooden trusses with galvanized metal gussets. The trusses were spaced approximately 24" OCD and supported exterior grade plywood roof decking. These structures displayed no signs of water staining, warp, twist or physical damage.

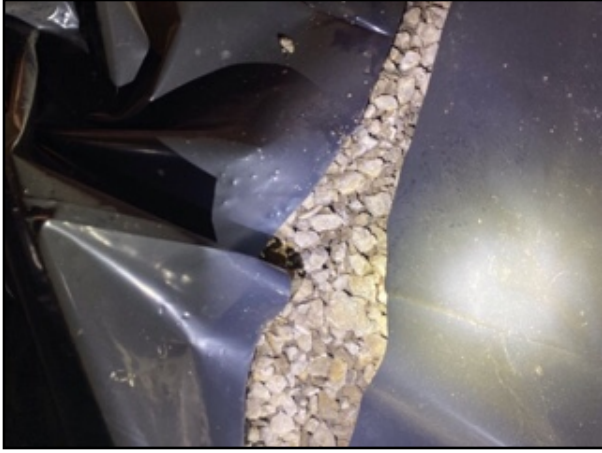
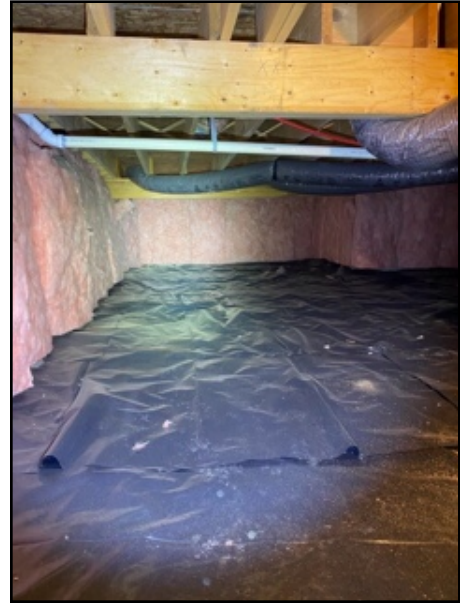
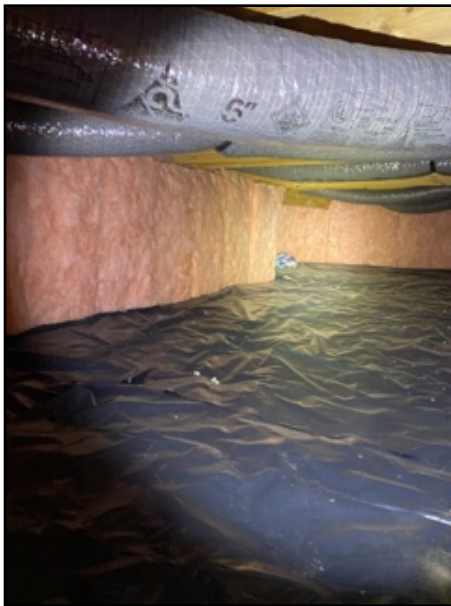
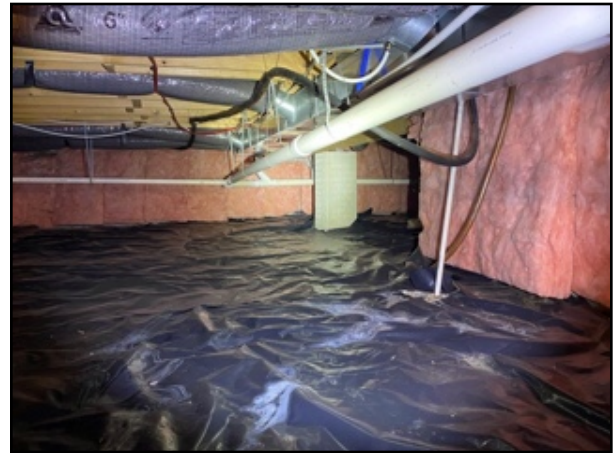
Comment 28:
Crawlspace floor is gravel. Vapor barrier noted.

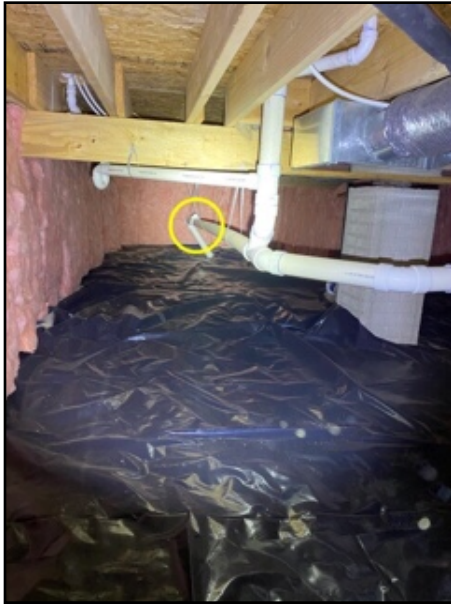
Figure 31-1

Comment 31:
Drain/Waste/Vent system was PVC and displayed no signs of leakage or physical damage and were proper sloped where able to be inspected. All drains were operated and flowed freely.

Main clean out in crawlspace.

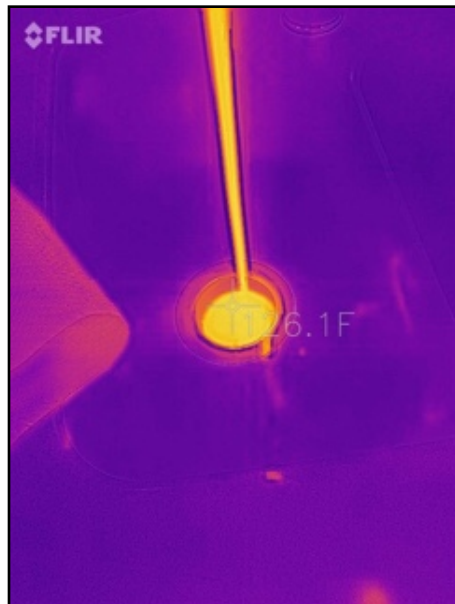
Figure 32-1

Thermal imagine shows water temperature of 126.1 F at kitchen sink.

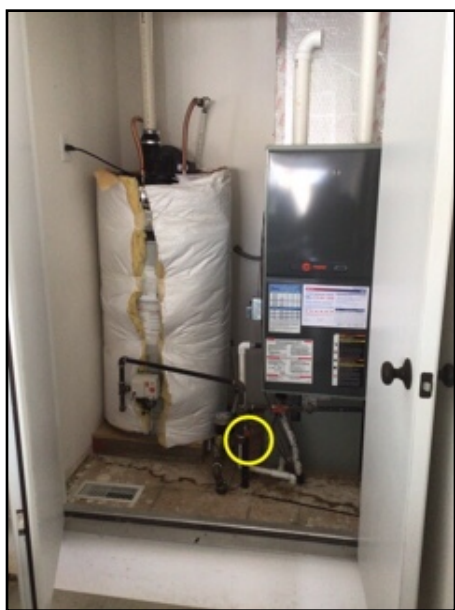
Figure 34-1

The water heater was a Bradford White, 50 gallon unit, manufactured in 2006. Its model and serial number was checked against the Consumer Product Safety Commission and the manufacturer's website and no defect or recall notices were found.

The water heater was properly installed with flexible copper connector. The TPR valve was properly vented to an approved pipe. The water heater was power vented by PVC pipe. The water heater's gas shut-off valve is indicated.

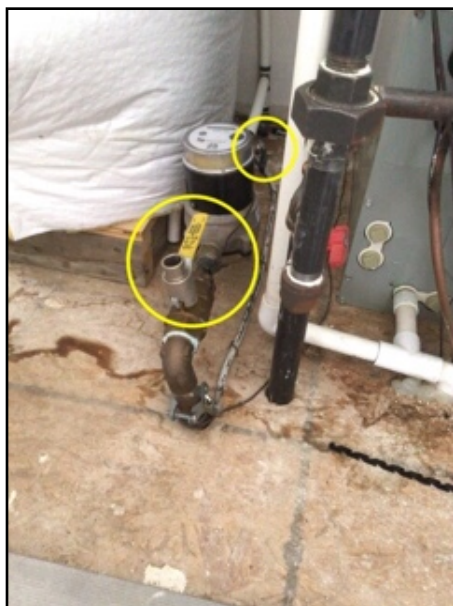
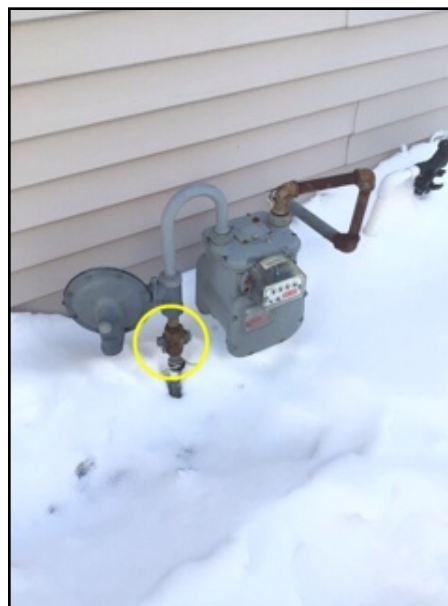
Main water shut-off was located in the garage. The meter was properly equipped with a ground bonding jumper wire around the water meter.

Main fuel (natural gas) shut-off was located on the utility meter.

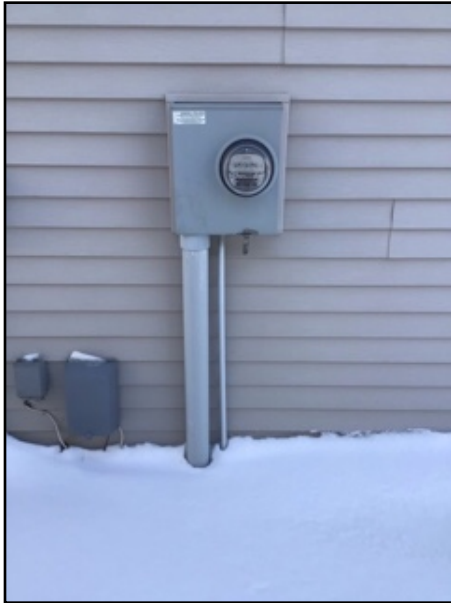
Figure 38-1

Electrical service is supplied by means of an underground (lateral) service drop from the utility pole to the meter box located on the side of the house. The meter was rated for 200 amp service.

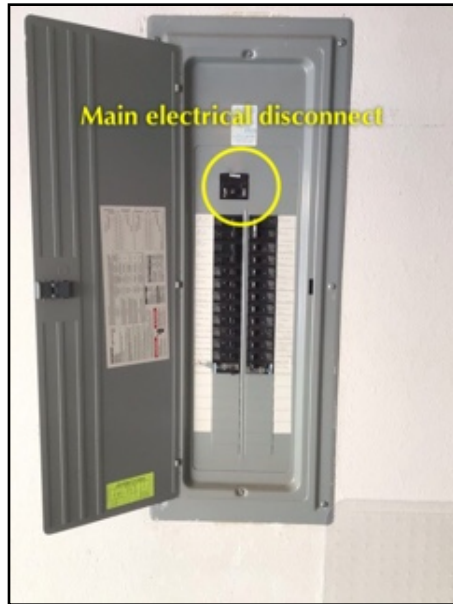
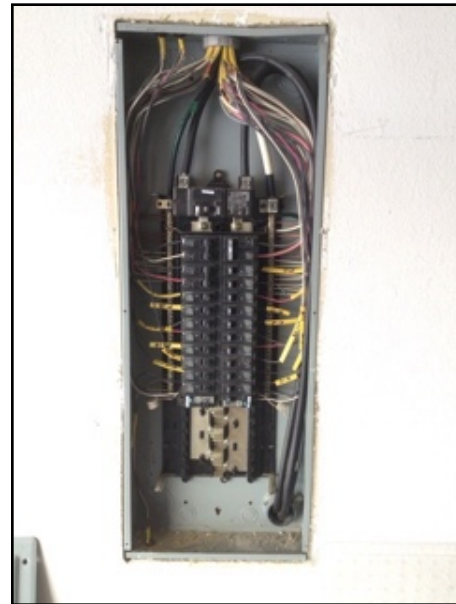
The electrical distribution panel and the main disconnect were located in the garage. It was rated for 200 amps and without signs of physical damage, rust or pest infiltration. The panel face is properly secured by blunt end screws.

The service entrance cables are of the proper gauge. All overcurrent devices were properly seated and of the proper type for the panel.

All raceways are nonmetallic sheathed and are properly secured and bonded. The grounding conductor and the neutral conductor are properly floated and the ground conductor was properly bonded to the panel.

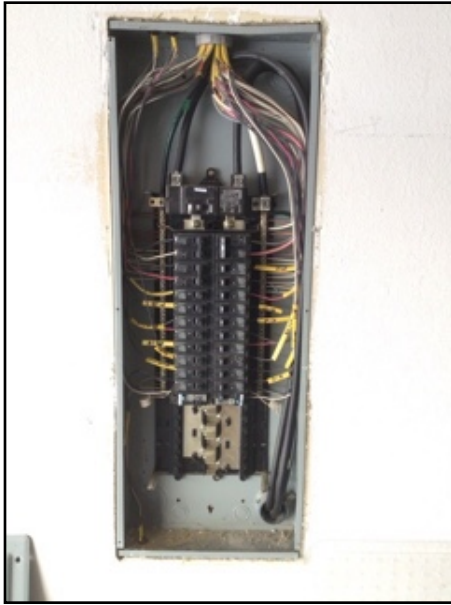
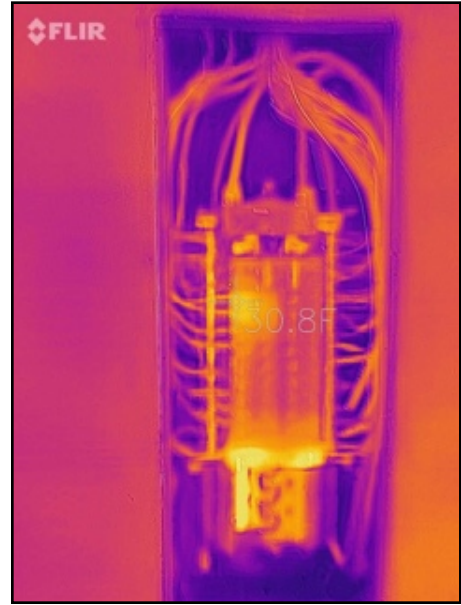
All inspected overcurrent devices (circuit breakers) were of the proper type and were served by the correct gauge wire for their rated amperage. There were no double taps. All neutral conductors are properly seated in the neutral bus and the neutral bus is properly floated from the panel and the ground.

Thermal imaging suggests temperatures are within normal ranges.

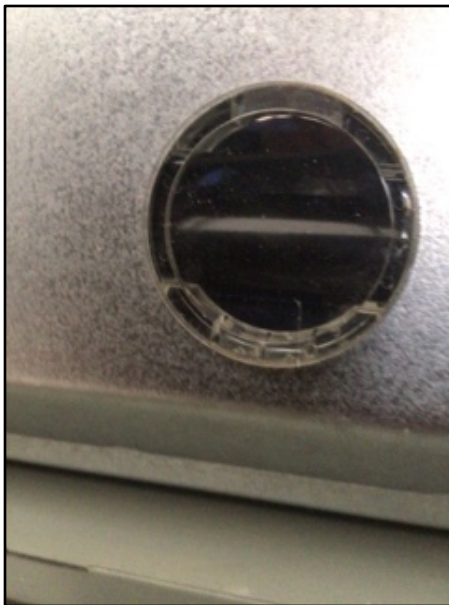
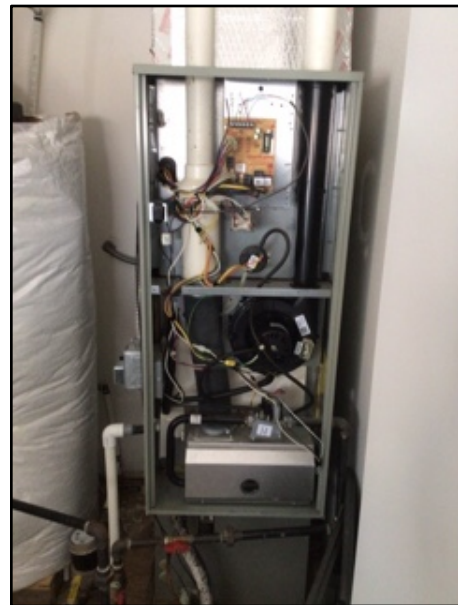
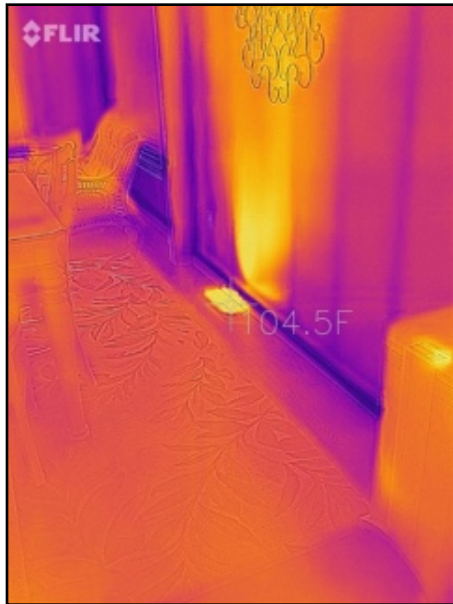
The house was heated by a Trane, high-efficiency furnace, manufactured in 2006 and located in the garage. Gas and electrical shut-offs indicated. The furnace's serial number was checked against Consumer Products Safety Commission and the manufacturer's website for defect or recall notices and none were found.

The unit operated and displayed the proper color flame.

Thermal imaging shows air temperature at register of 104.5 F.

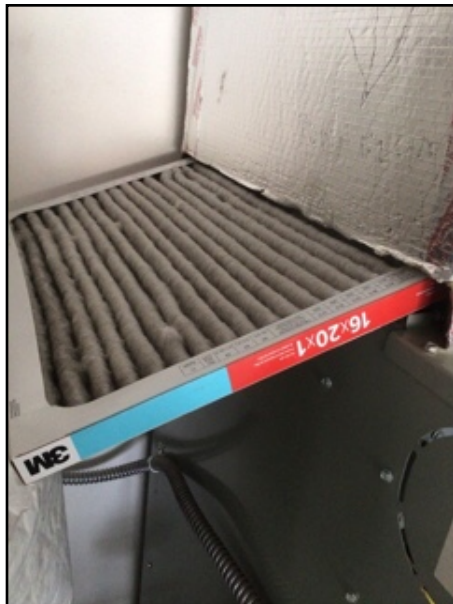
Figure 47-1

Filter size 16*20*1

Recommend the furnace's filter be replaced. The use of HEPPA or so-called '90 day' furnace filters is not recommended.

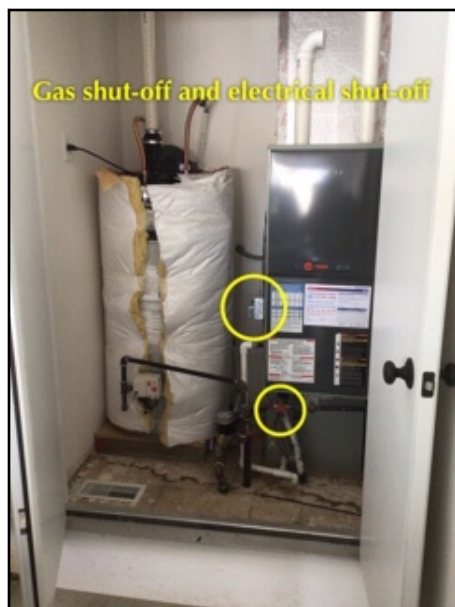
Figure 48-1

Furnace responded properly to normal operating controls. Thermostat was located in living room.

Furnace was equipped with gas shutoff and electrical shutoff located on the furnace unit.

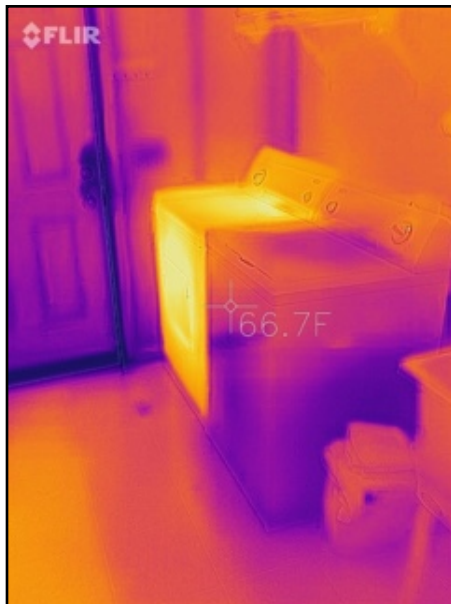
Figure 60-1

Washing machine and dryer were present. Laundry equipment was triggered on and off using the primary functions. Both machines appeared to be functional, however; inspecting the adequacy and effectiveness of the laundry machines is beyond the scope and not possible during a home inspection.

Thermal imaging suggests the dryer gets hot and the washing machine appears leak free.

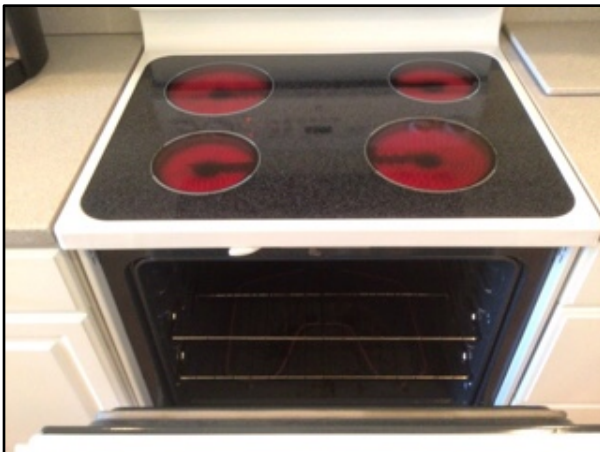
Figure 62-1

Range and oven operated.

Model and serial number was cross-checked against manufacturer and Consumer Product Safety Commission and no posted recalls were found.

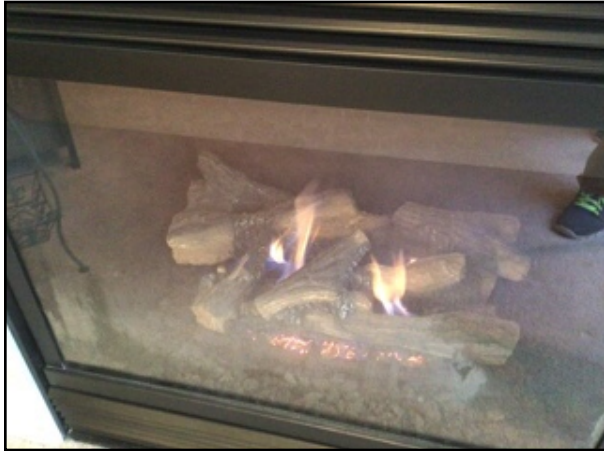
Figure 67-1

The house was equipped with a direct vent gas fireplace. The unit was operated and functional.
